Fractography Solutions - All images from ASM Vol 12, 9th edition

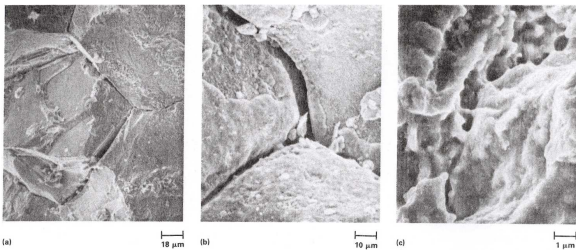
Fig 2 – (ASM p173) Ductile fracture of copper. The equiaxed dimples are consistent with tensile load.

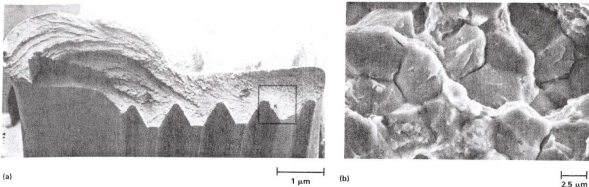
Fig 3 – (ASM p26) Intergranular cracking is consistent with many types of failure mechanisms. These happen to be creep fractures of Inconel 625, Incoloy 800, PE-16-grain boundary cavitation.

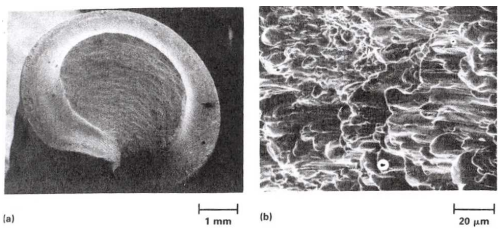
Fig 4 – (ASM p24) AISI 8740 is a high strength steel (>150ksi, 40RHC) and is therefore highly susceptible to hydrogen embrittlement. Intergranular cracking is consistent with hydrogen embrittlement. Likely cause was inadequate baking after cad plating.

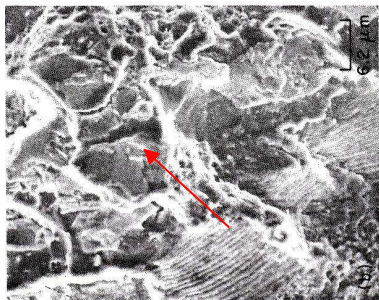
Fig 5 – (ASM p6) elongated dimples indicate shear failure. It appears the screw failed due to shearing and not tensile overload.
