University of Portland
School of Engineering
ME 421/521 – Failure Analysis
Fall 2011

- 5) Complete Phase I and II for the fan motor mounting leg failure problem. Note: very little additional information other than that provided in the letter (below) is available from me, so you may create a list of questions, but I may or may not be able to answer them. Nonetheless, start an investigation data log and proceed with the limited background data available (data logs available on the course web page). Phase I includes many things besides asking questions of the customer. It would be appropriate to perform a literature search for resistance welding, organizing the data and information you do have, and sketching the parts available. Do not conduct any testing yet other than visual.

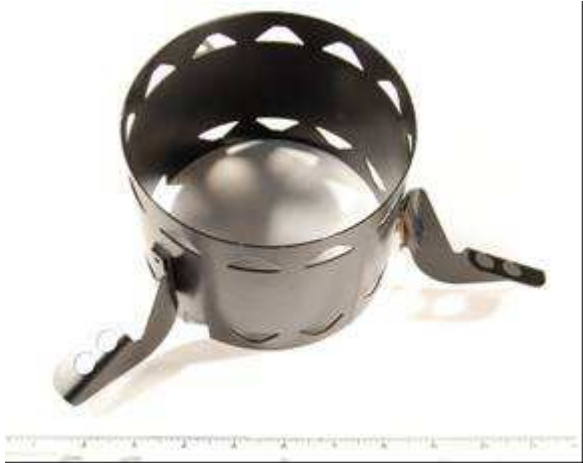
Figure 1 – band with legs (leg on right has been “chisel” tested).

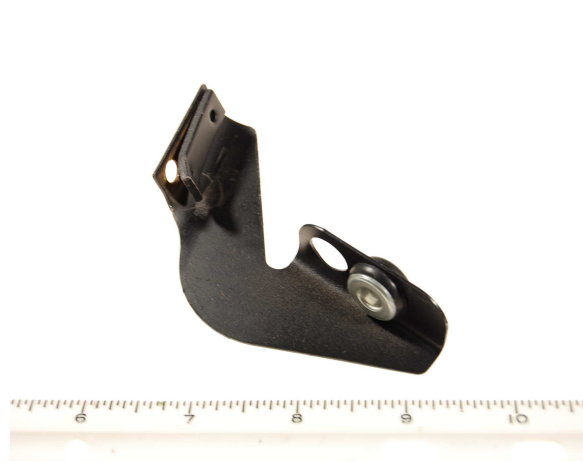
Figure 2 – leg that has been chisel tested.

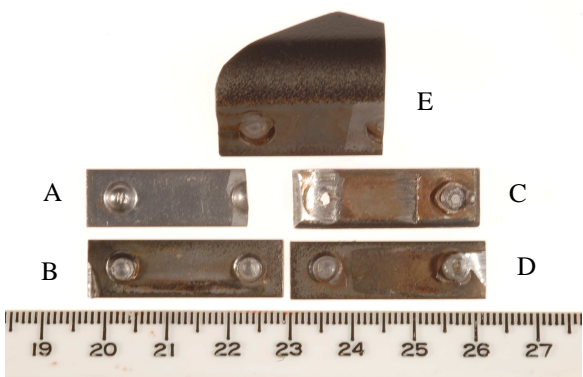
Figure 3 – various tabs that have all failed the “chisel test” except “A” – it has not been welded but was sectioned.

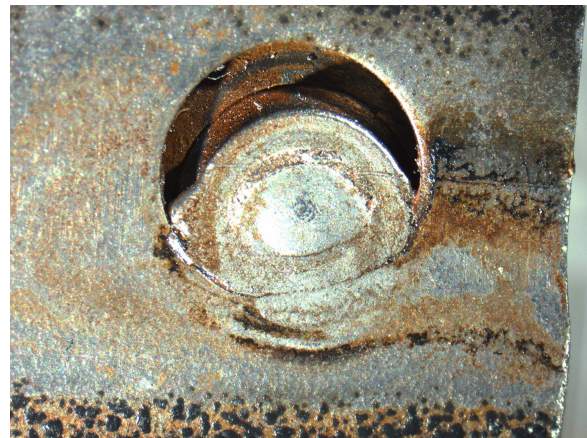
Figure 4 – close up of failed weld on tab “E” (see figure 3). The “rust” (red) developed sometime after testing.

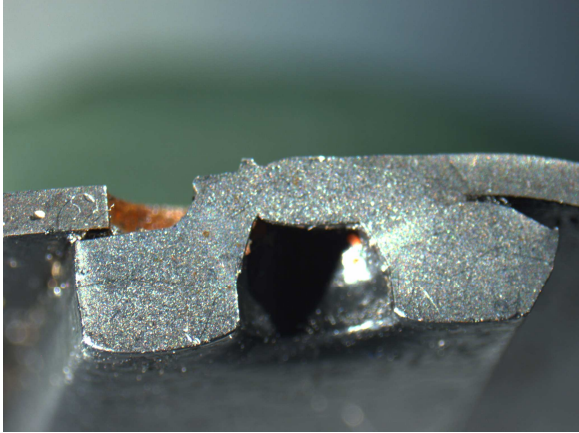
Figure 5 – close up of cross-section through failed weld, tab Sample “E” in Figure 3.

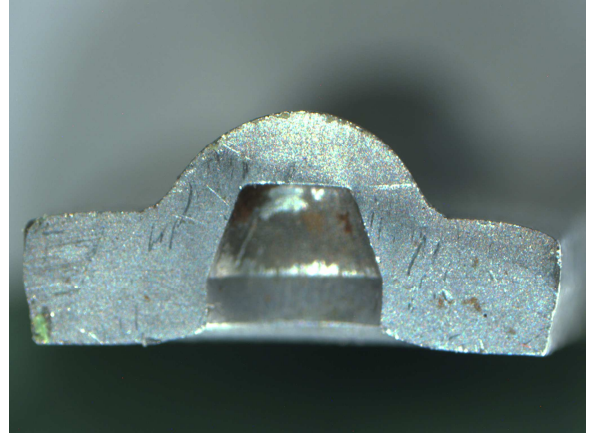
Figure 6 – cross-section through non-welded tab (sample “A” in Figure 3).

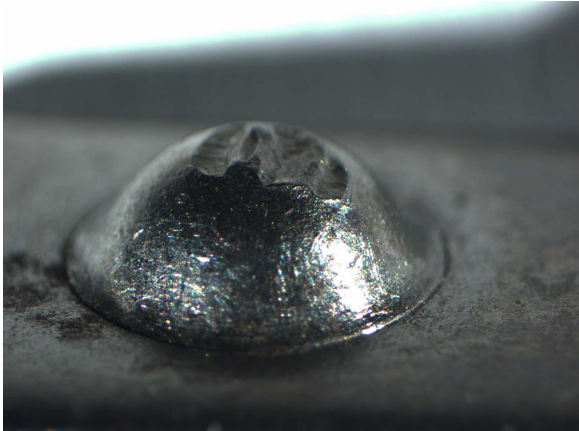
Figure 7 – non-welded tab (Sample “A” in Figure 3). Note “dents” on the tab are due to poor handling and are not typical of production parts.
