Fractography – Principles and Practices
Scanning Electron Microscope
SEM Fracture

Understanding How Components Fail

Donald J. Wulpi

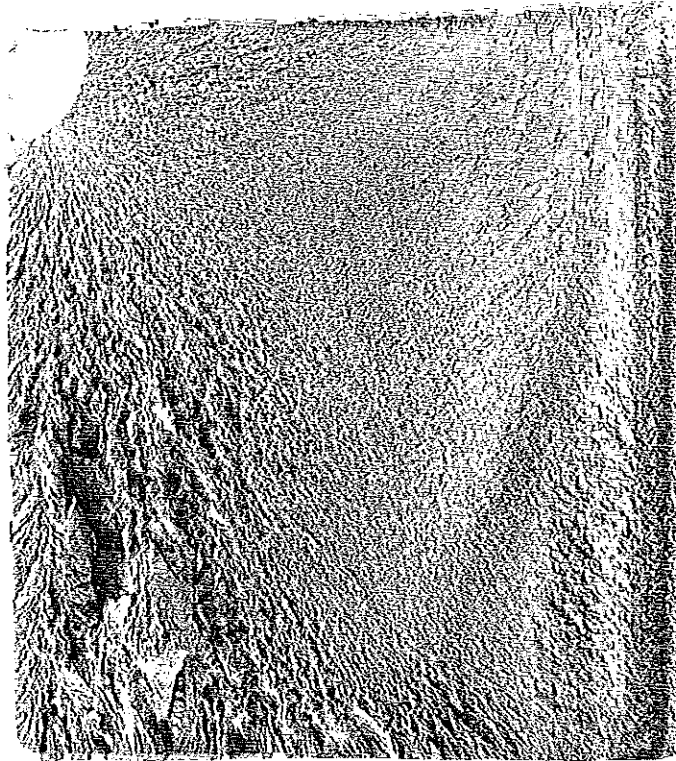
Fig. 9(a). Fracture surface of a large (approx $5\frac{3}{4} \times 6$ in.) equalizer bar made from D6B steel heat treated to a hardness of HRC 45 to 47.

This bar, which supports the front end of a large crawler tractor, was in service for about 200 h and was then returned to the laboratory, where it was flexed in high-stress, low-cycle fatigue, fracturing at 60,000 cycles. Note that the fatigue-crack zone at upper left has a very fine texture, the result of continual testing. Note also the radial, fan-like ridges emanating from the fracture origin and the very small shear lips around the periphery of the brittle fracture. This fracture of a very large, high-strength part released a large amount of energy in a very short time.

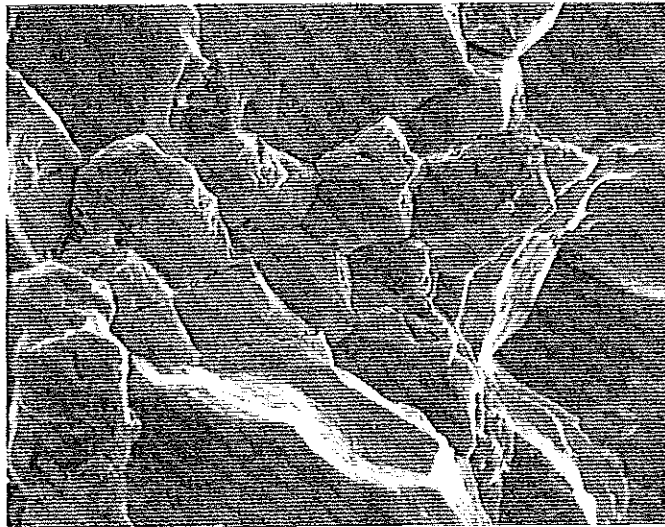
Fig. 14. Intergranular fracture in hardened steel, viewed under the scanning electron microscope. Note that fracture takes place between the grains; thus the fracture surface has a "rock candy" appearance that reveals the shapes of part of the individual grains. 2000 \times ; shown here at 75%.

while the bricks are analogous to the metal grains. A typical intergranular fracture is shown in Fig. 14.

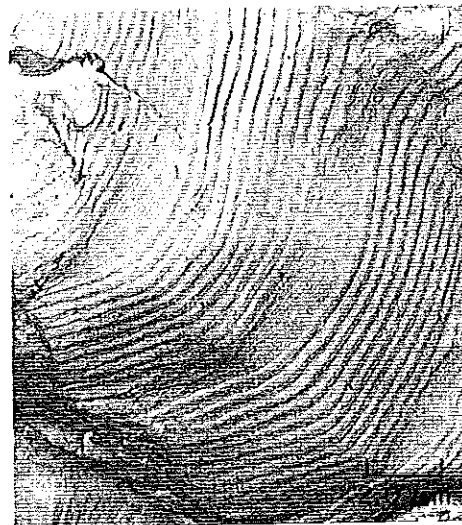
In this test, the specimen was loaded 10 cycles at a high stress, then 10 at a lower stress, and alternated with these stresses as the fatigue crack continued to propagate. This produced 10 large striations, then 10 small striations, alternately, across the fracture surface. 4900 \times . (Ref 5)

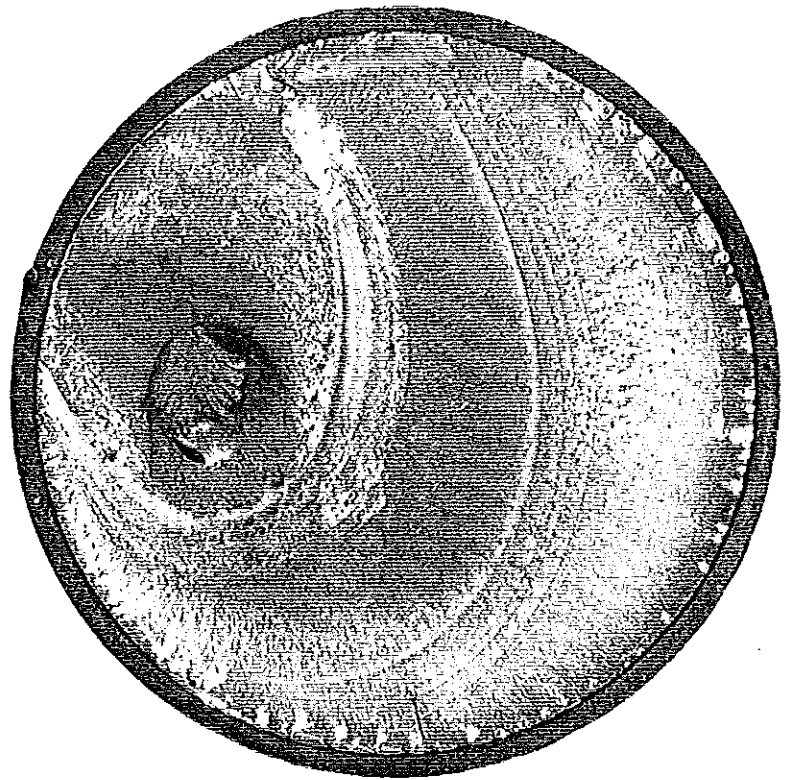
Fig. 10. Surface of a fatigue fracture in a 1050 steel shaft, with hardness of about HRC 35, that was subjected to rotating bending.

Presence of numerous ratchet marks (small shiny areas at surface) indicates that fatigue cracks were initiated at many locations along a sharp snap-ring groove. The eccentric pattern of oval beachmarks indicates that the load on the shaft was not balanced; note final rupture area (stage 3) near left side.
