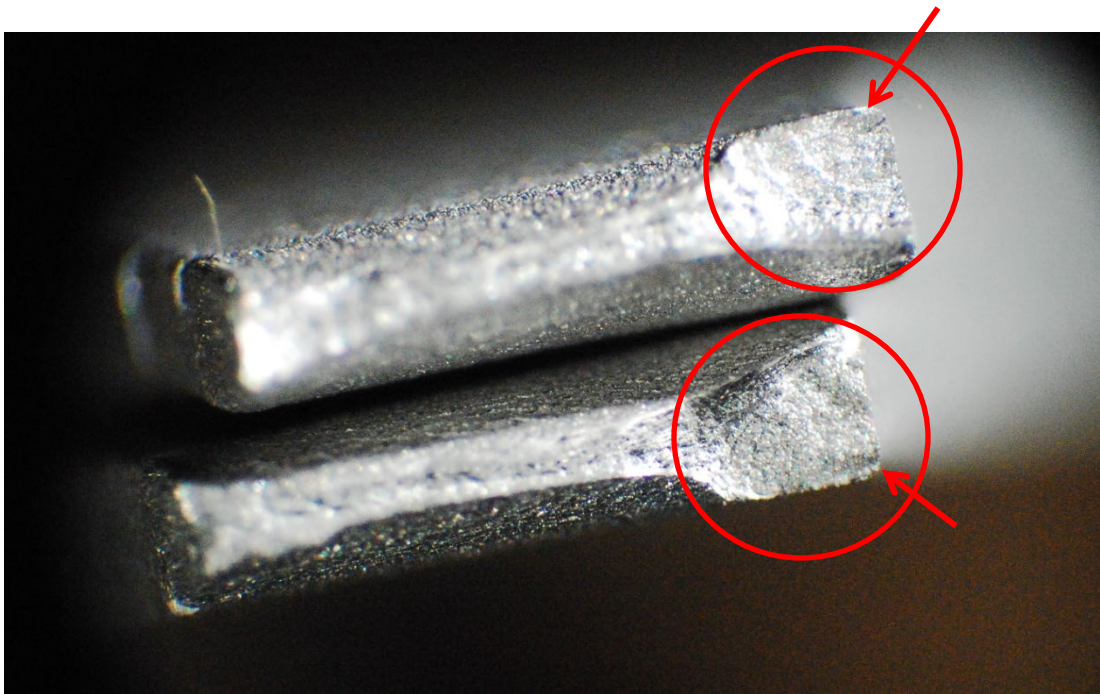
Two halves of the fracture surface of an aluminum fatigue failure. Loading was from zero to tension ($\sigma_m > 0$). The circled areas are where fatigue cracks initiated and slowly propagated each load cycle until the crack became “unstable” – meaning the crack within in very few (perhaps 1 single load cycle) propagated along the remaining cross-section. Arrows indicate probable location of crack initiation. A crack becomes unstable when it reaches a critical length; less material remains the longer the crack becomes and also the stress intensity (stress concentration) is greater for longer cracks. Looking closely at the fatigue fracture surface one can see “beach marks” – macroscopic semicircular features characteristic of fatigue. (photo credit: Peter Chamberlain and Maddy Sickler).

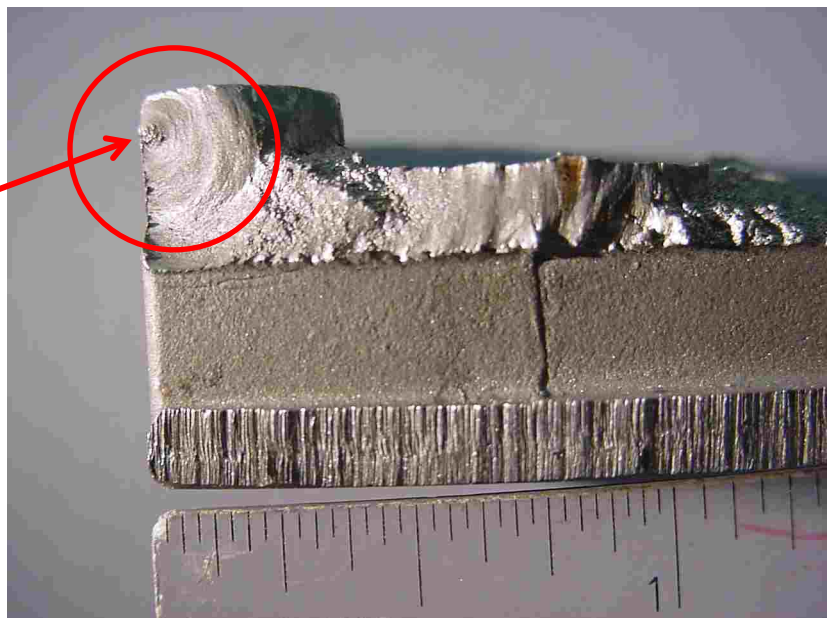
Fatigue failure from a fork-lift upright. Fatigue crack initiated from an *interior* defect in the casting. Fatigue beach marks are evident within the circled area (the crack grew slowly each time the load was applied) and outside the circled area the brittle fracture grew in a single overload resulting in a broken part.
