European Structural Integrity Society

TC24 – Structural Integrity of railway components

Seminar: 3-4 March 2011

Predicting real world axle failure and reliability

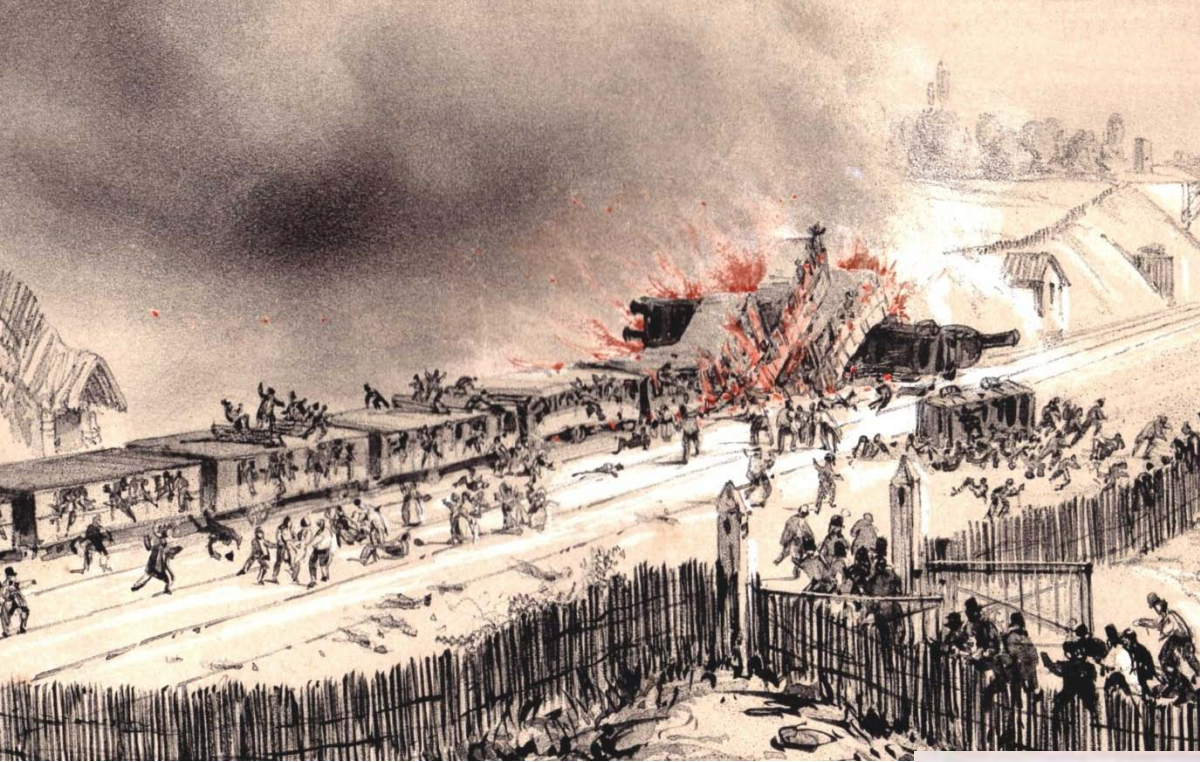
The Versailles accident of 8 May 1842.

Broken axle - derailment of engine – fire in wooden carriages – doors locked – approx. 70 killed

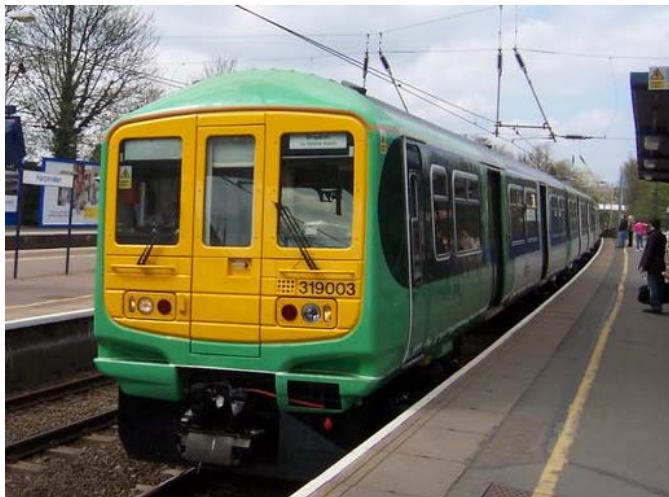
- **Trial Vehicle: Southern Class 319 EMU**

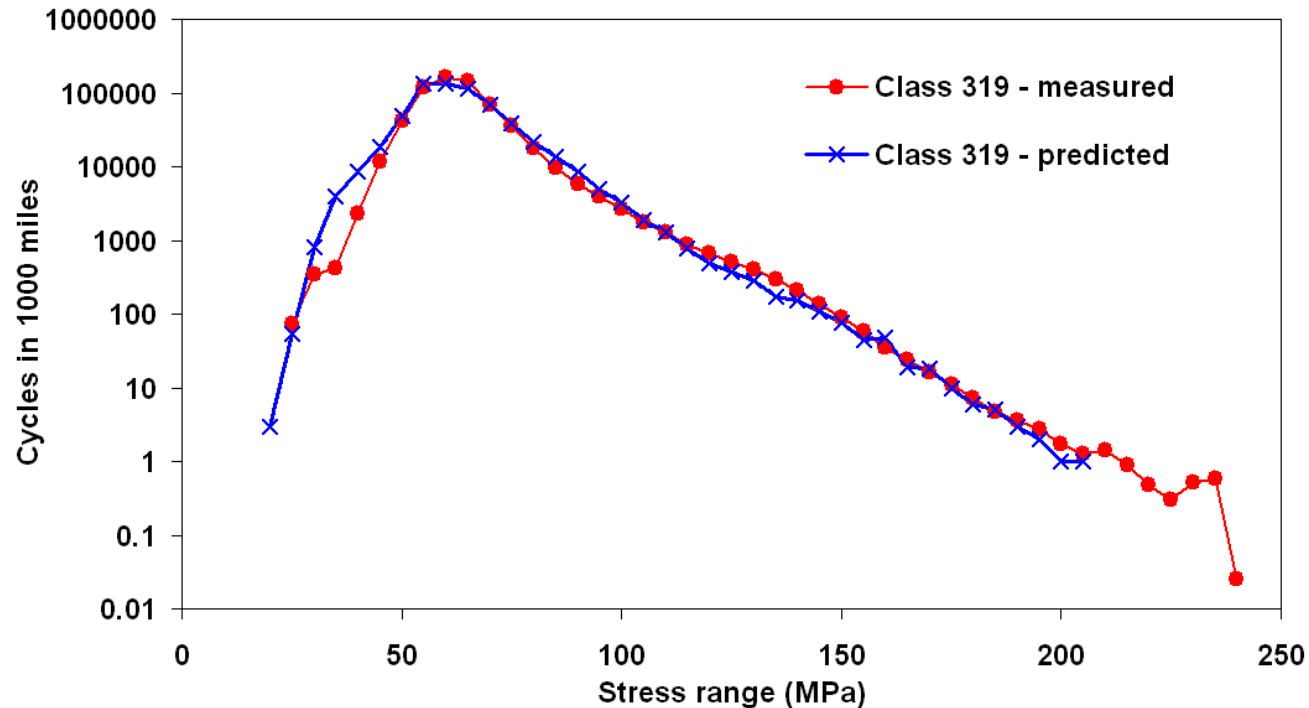
Validation: Class 319 histogram

Calculated Failure Probabilities at 125,000 mile UAT interval:

- Based on measured histogram: 0.000451%
- Based on predicted histogram: 0.000415%
- Measured / Predicted: 1.09 (within 1.3 threshold)

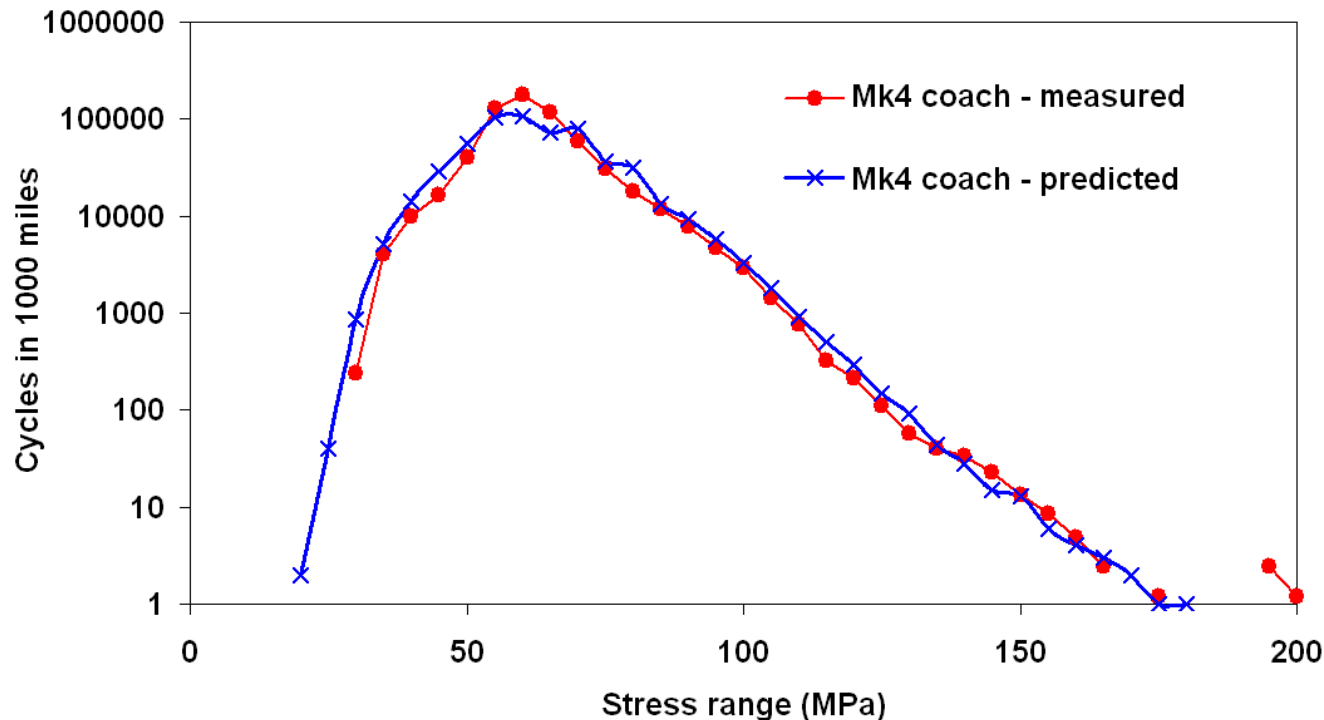
Validation: Mk4 coach, Kings Cross - Glasgow

Calculated Failure Probabilities at 125,000 mile UAT interval:

- Based on measured histogram: 0.000223%
- Based on predicted histogram: 0.000328%
- Predicted / Measured: 1.47

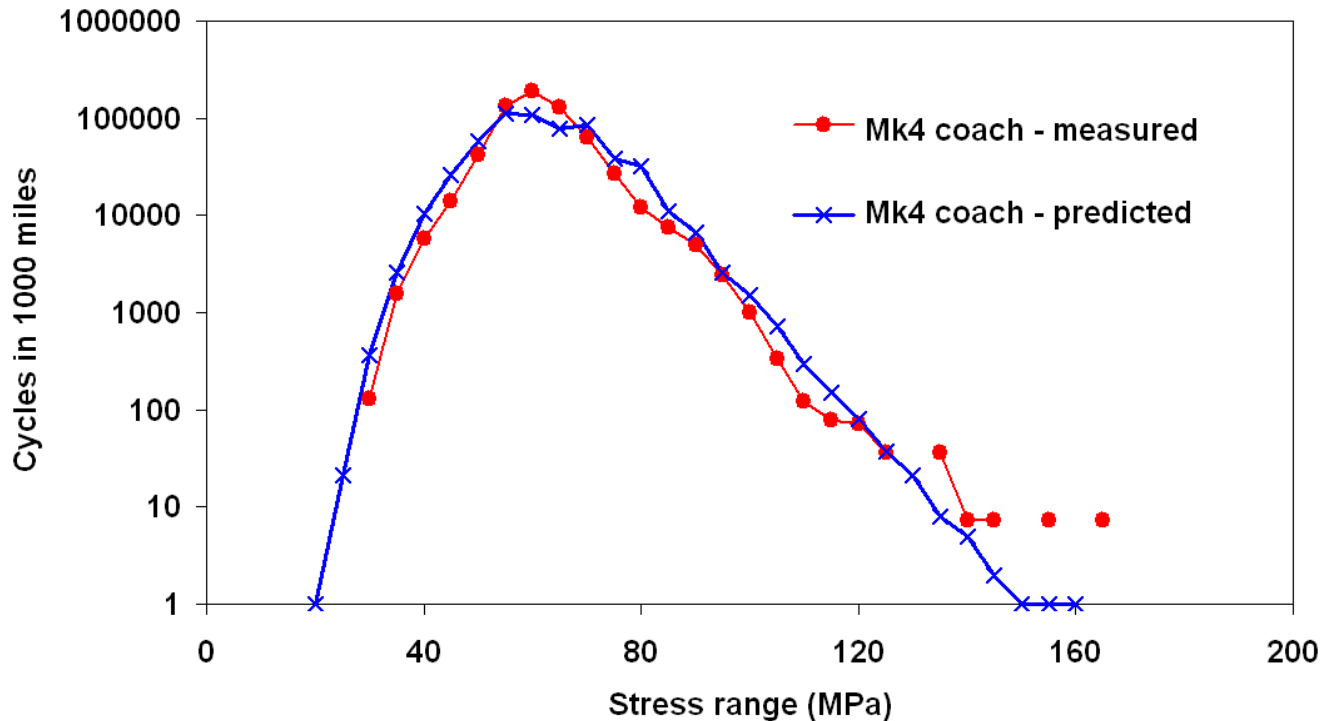
Validation: Mk4, Kings Cross - Peterborough

Calculated Failure Probabilities at 125,000 mile UAT interval:

- Based on measured histogram: 0.000071%
- Based on predicted histogram: 0.000107%
- Predicted / Measured: 1.51

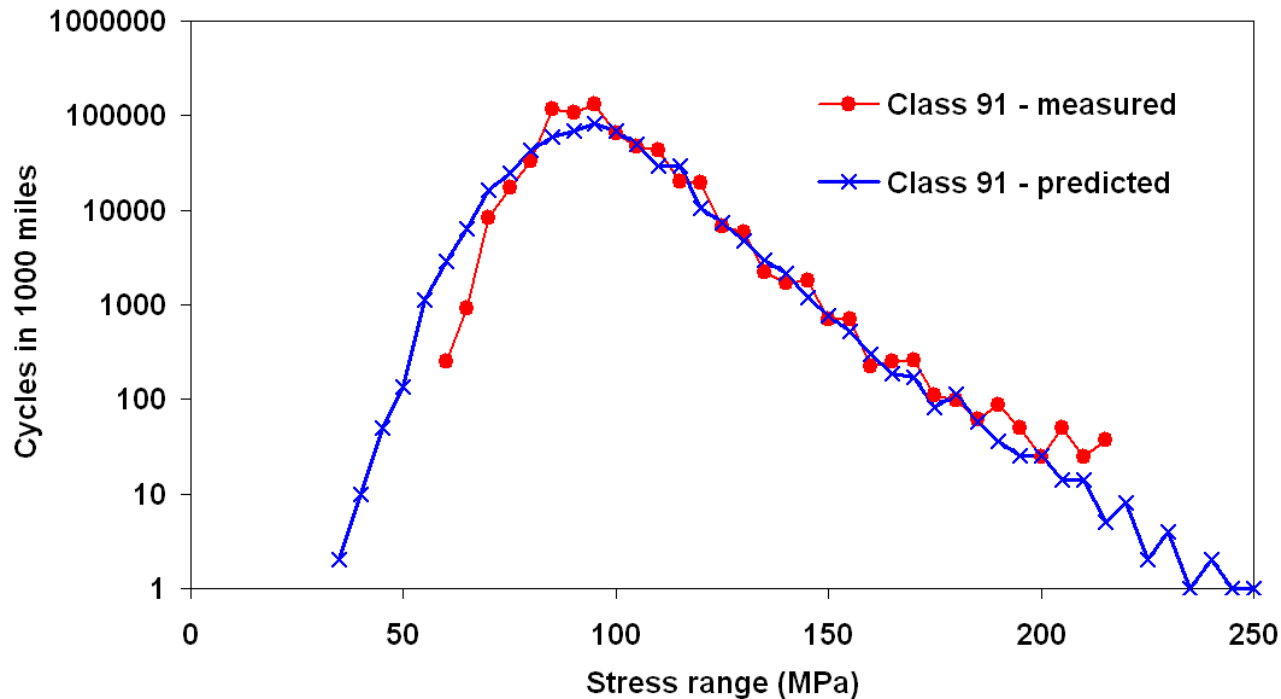
Validation: Class 91, 105 miles of ECML

Calculated Failure Probabilities at 125,000 mile UAT interval:

- Based on measured histogram: 0.0153%
- Based on predicted histogram: 0.0125%
- Measured / predicted: 1.22

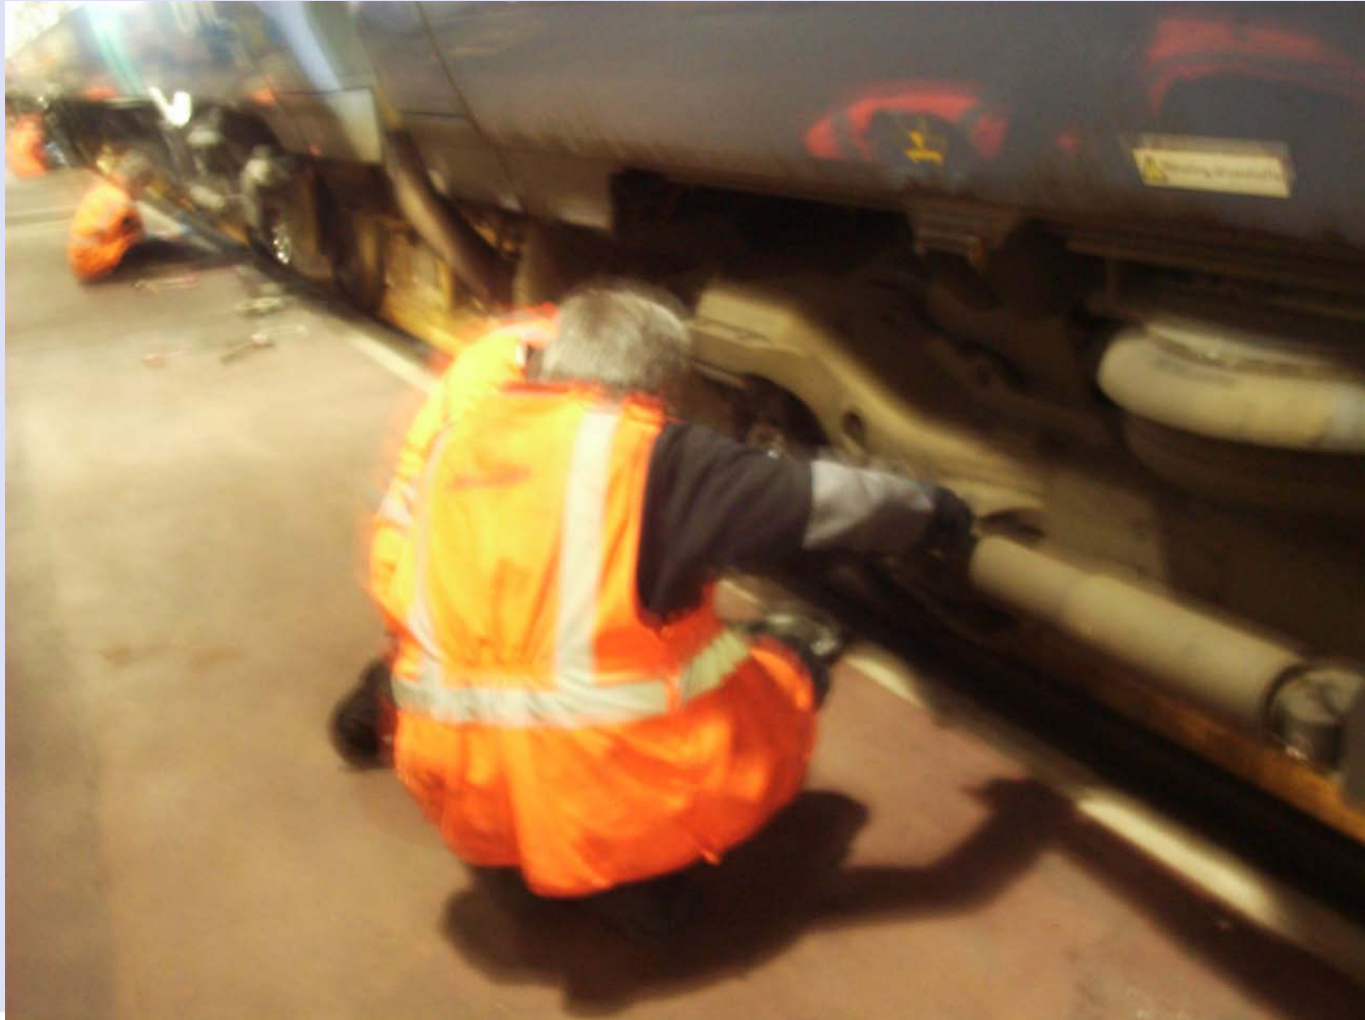
Far end UT in progress

- Can be carried out on exposed surfaces with axles in-situ
- Requires “small” probe to scan surface
- Can scan through non-conductive coatings/with minimum cleaning
- Visual/audible indication from instrument
- Requires operator to have manual dexterity as well as interpretation skills and alertness

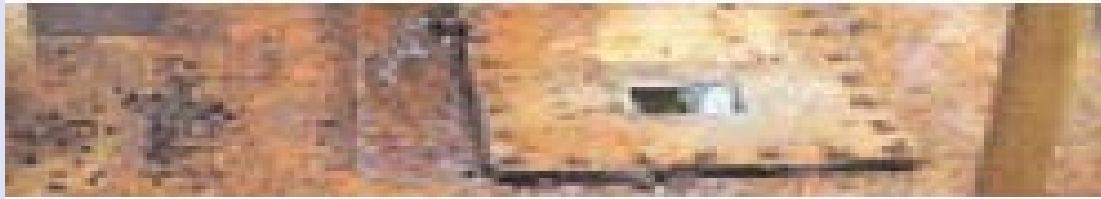
<0.5mm

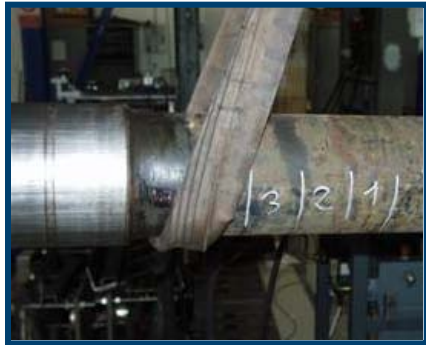
05-046A
(1978)

three A1N steel railway axles retired from service

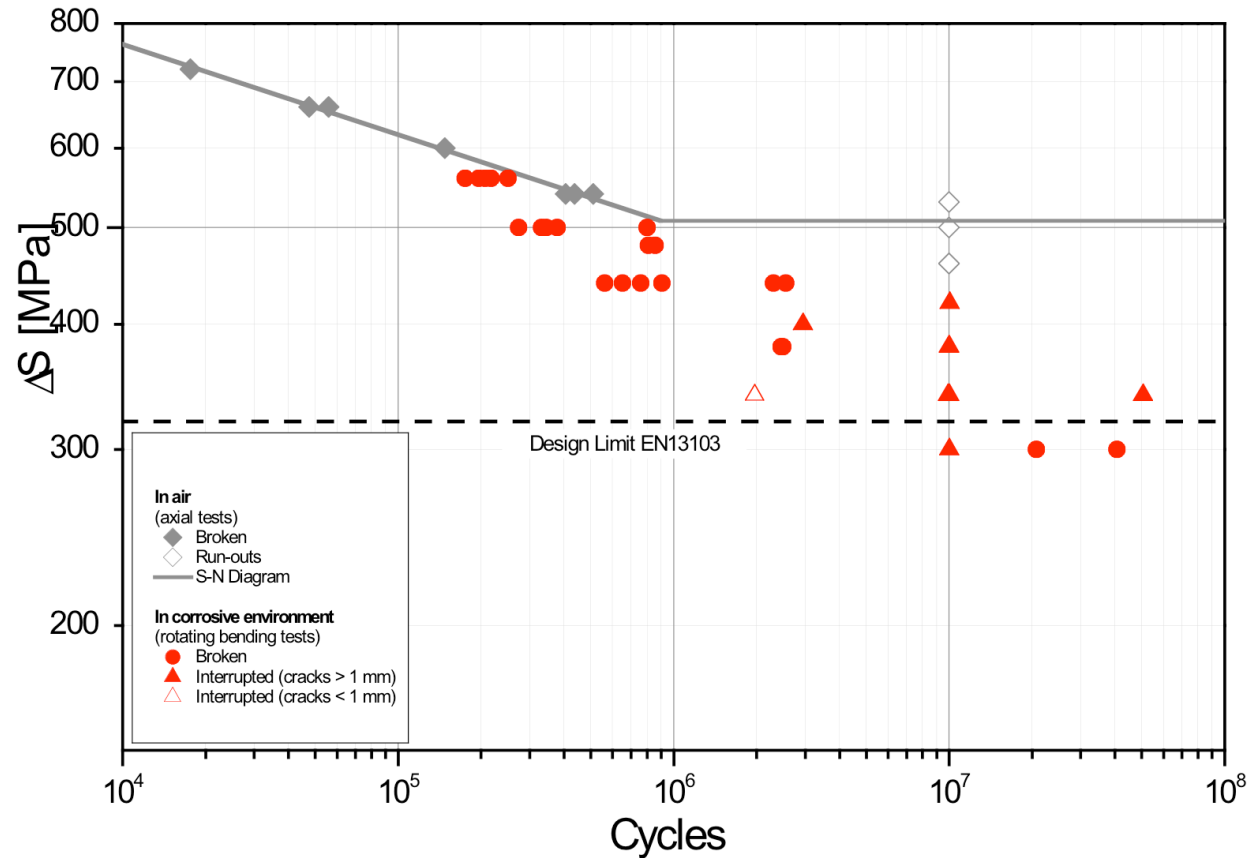
S-N diagram under corrosion intermittent dropping

- Results show a continuous decrease of fatigue life;
- No difference if we introduce pre-cracks;
- Corrosion potential ? Growth rate ?

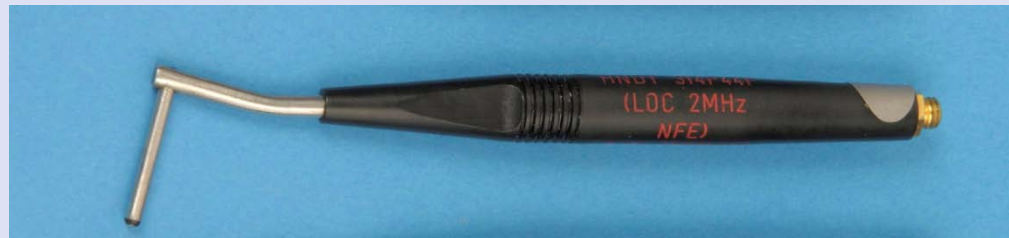
- **Using a very small diameter focused field 2 MHz eddy current probe (0.5mm core)**

- **Calibrate with lift off (50% screen height =0.140µm from 0.140µm plastic shim)**
- **Scan corroded areas looking for pit type signals (scan along plastic shim placed on surface)**

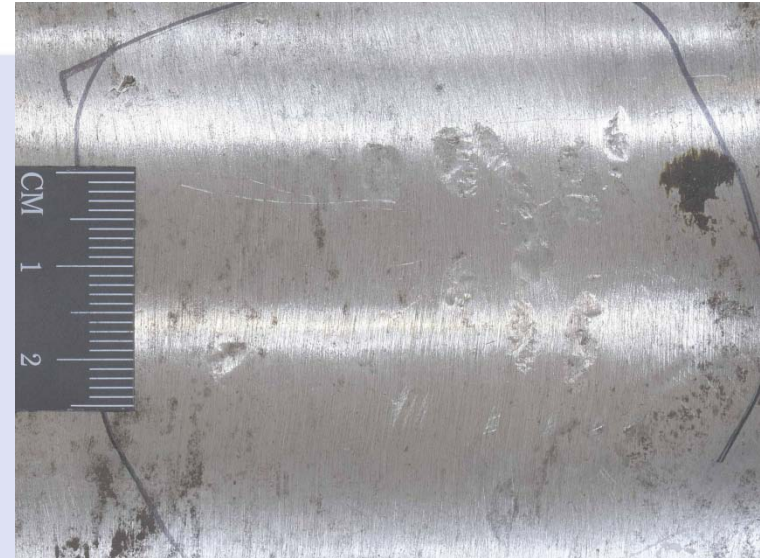
Max. surface mechanical damage depth: 0.88mm

Depth ranges from 0.11 to 0.39mm

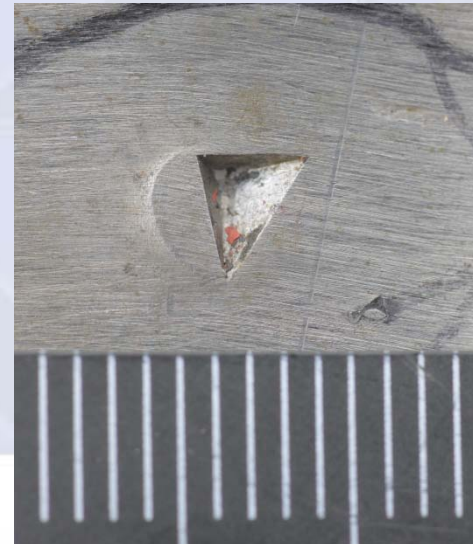
Max. depth:
0.94mm

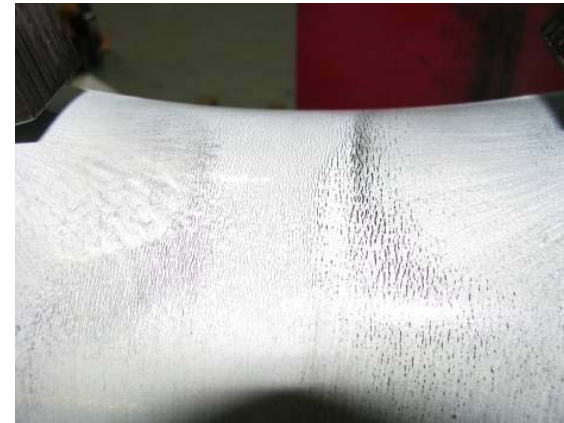
Validation of Axle Assessment Methodology – PoliMi Full-scale Axle Tests

- First test at constant amplitude (+/- 160 MPa)
 - Life within scatter band of small specimen tests used to develop corrosion fatigue model
- Second test based on an axle stress spectrum
 - Stresses increased to give 40 million cycle (60,000 mile) predicted life
 - Both predicted and measured cracks about 1.5 mm long after 15 million cycles
- “Hoddinott” type stress corrosion cracking observed in both tests

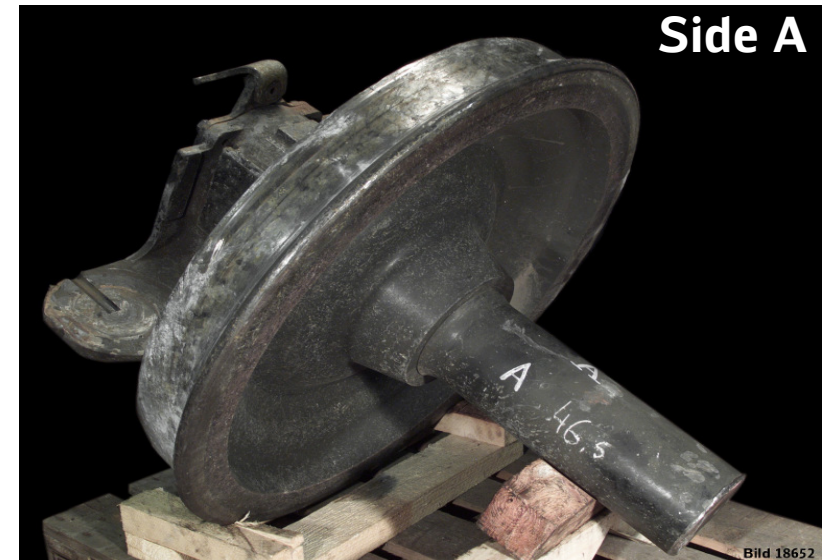
Wheelset axle breakage

- Axle was first in salt transport service before installation in bulk transport
- Running performance since last revision: ~ 74,000 km

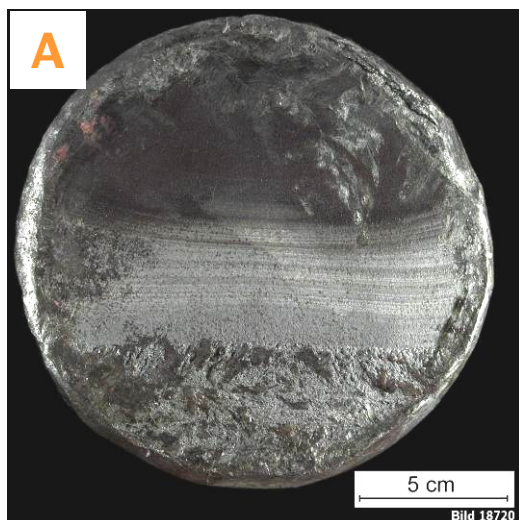
Fracture surface

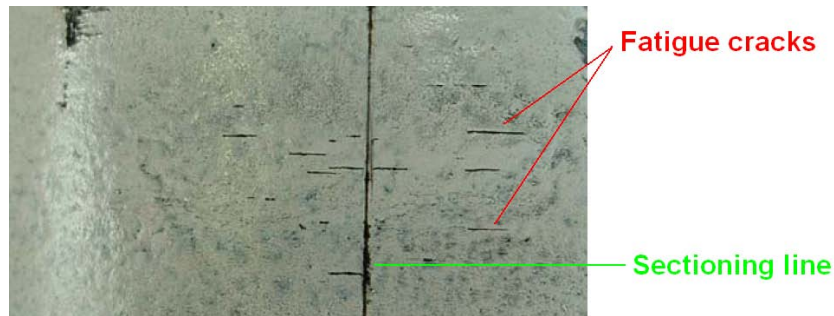
Corrosion Fatigue Case Histories – Mk3 Coach (current design)

- Axle found cracked by MPI inspection in 2003
- Cracking associated with region of heavy corrosion
- Further investigation indicated multiple cracks

- Other Mk3 axles reported with similar corrosion
- Two pointers toward corrosion fatigue
 - Multiple cracks on one axle
 - Multiple cracked axles (perhaps)

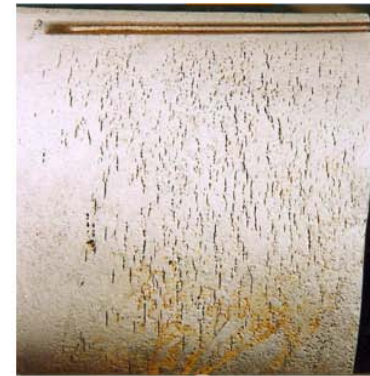
Norton Bridge

Shields Jn
(Hoddinott, 2003)

- Shields Jn case probably led to the term “Hoddinott cracking” for corrosion fatigue

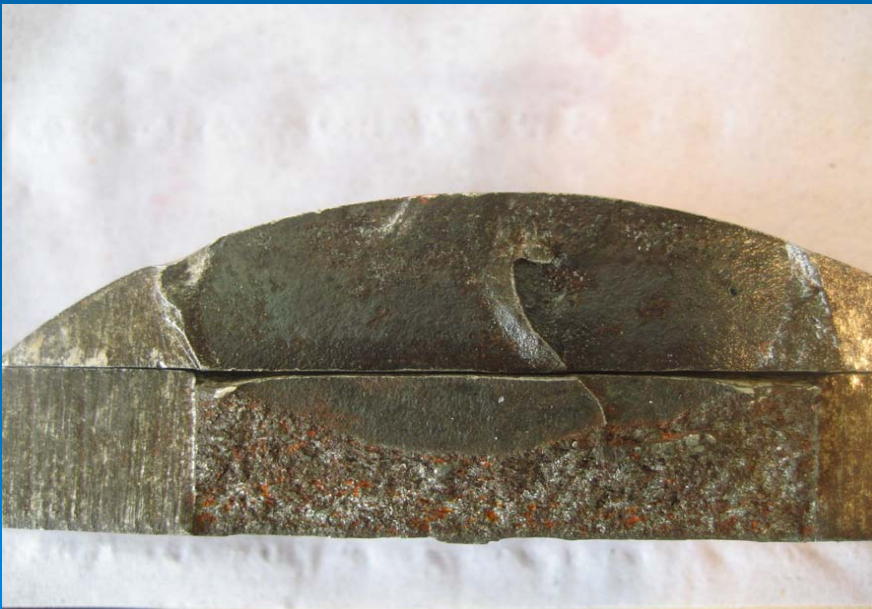
GB NDT Axle Testing & Defect Types Found.

- Large fracture face (mid-span crack)
- Small crack from corrosion pore

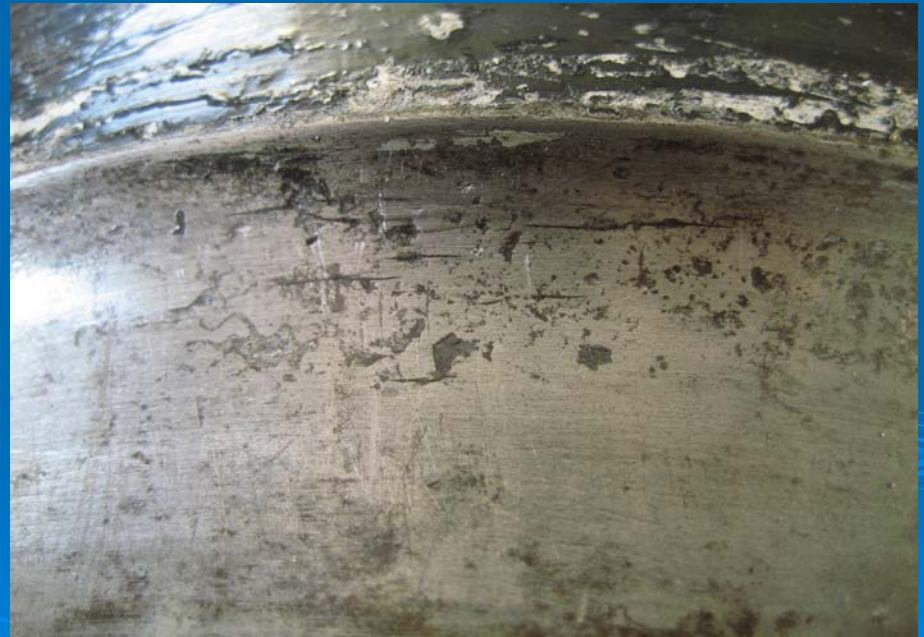
SAMPLE 3 COACH AXLE
SECTION RADII CRACKS
(MAX 12 X 1.6mm DEEP.

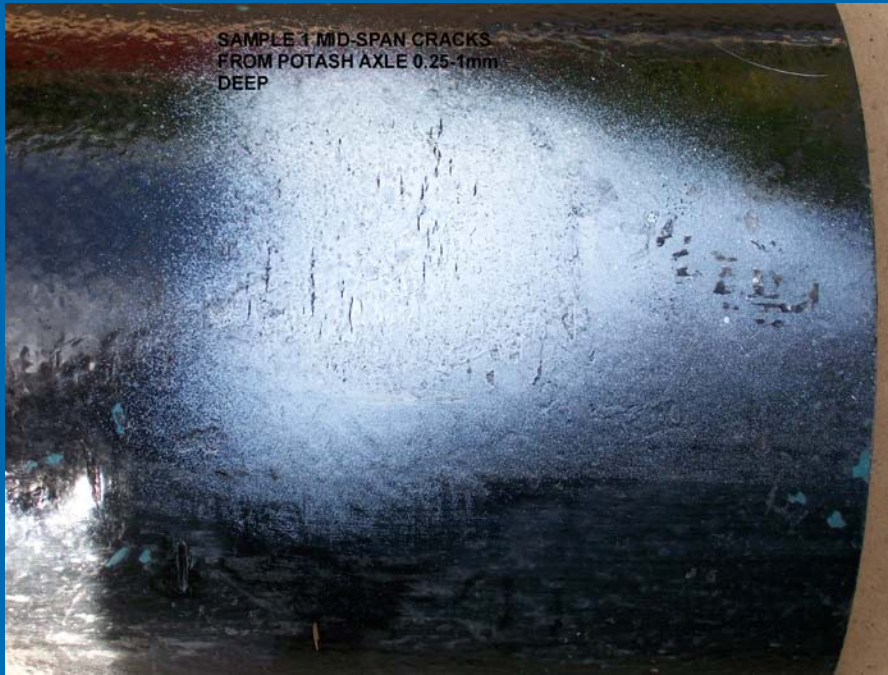
GB NDT Axle Testing & Defect Types Found. Cracks / Corrosion in potash axle sample

- Eddy current response from potash axle cracks & severe surface corrosion noise and crack non/ lightly corroded surface.

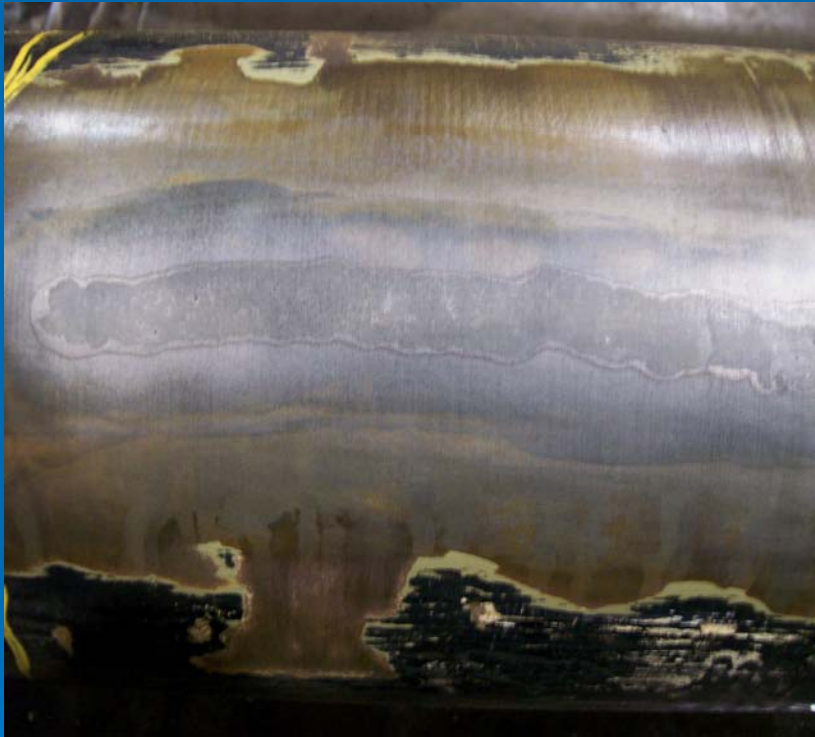
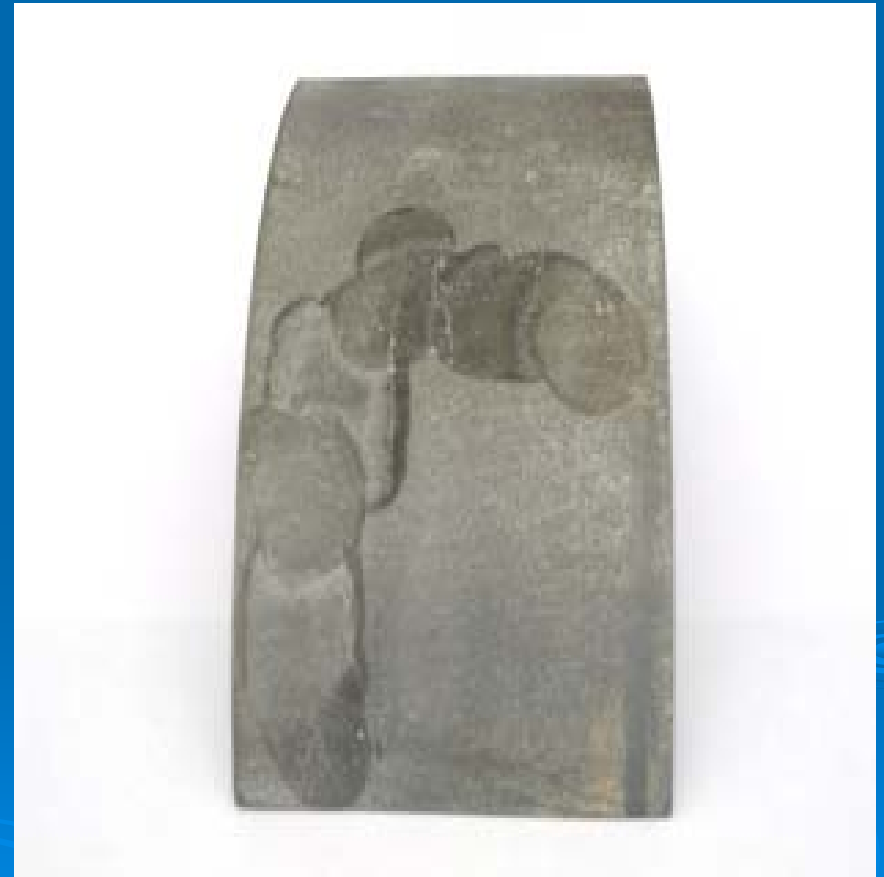
GB NDT Axle Testing & Defect Types Found.
**NDT Issues Regarding Axles in Recent Years. (Weld
repaired axle)**

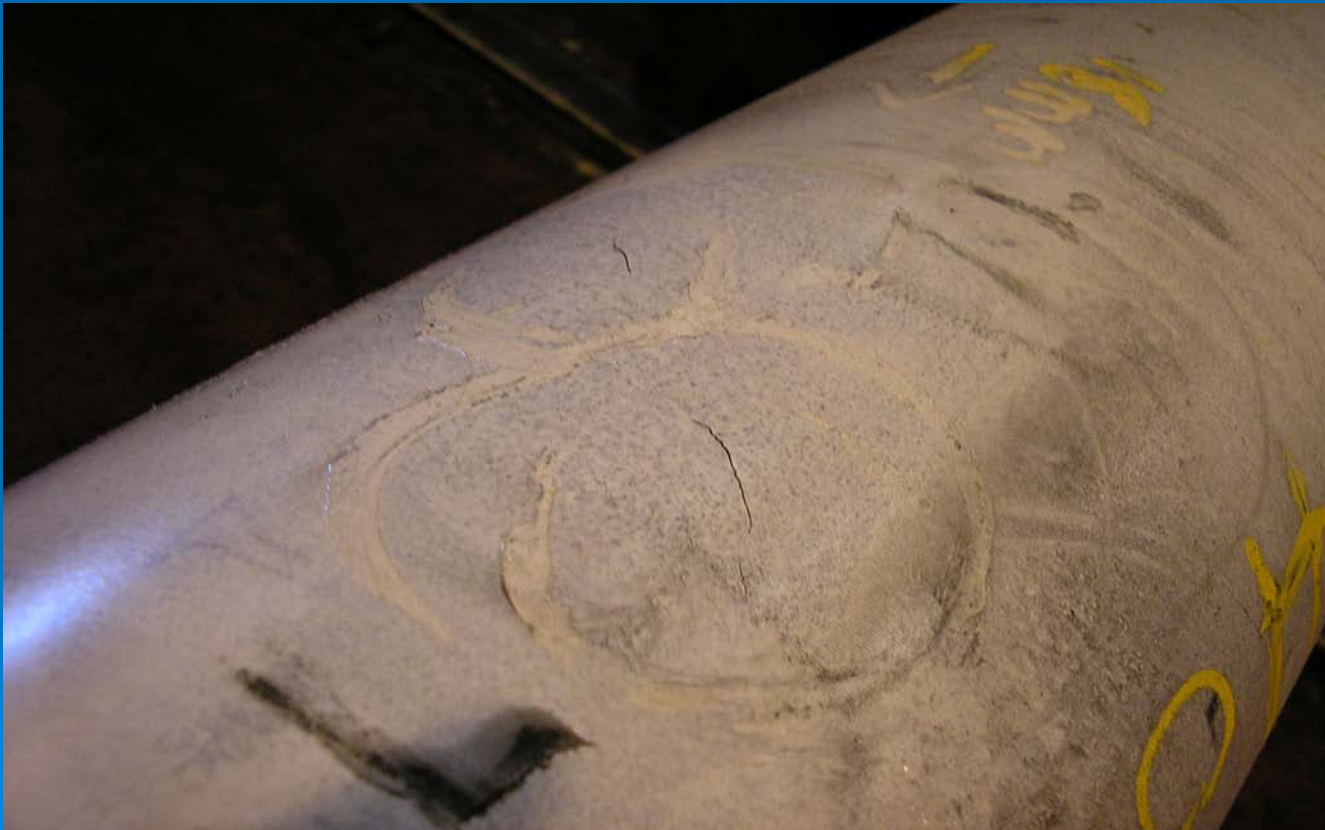
- Cold Lap in an axle body

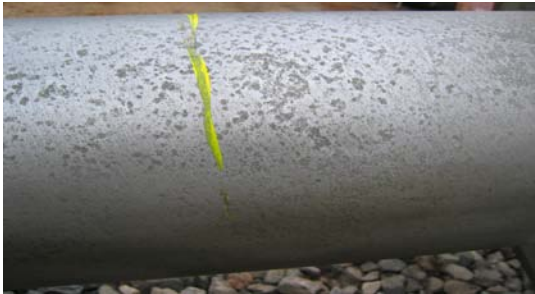
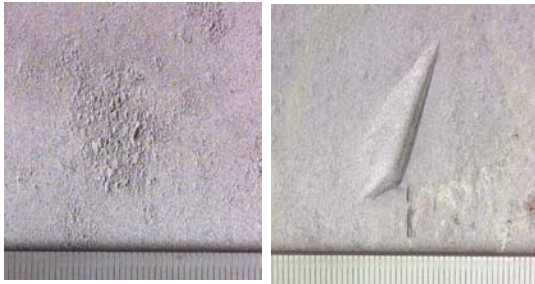
Theoretical and actual

Alicona Infinite focus microscope

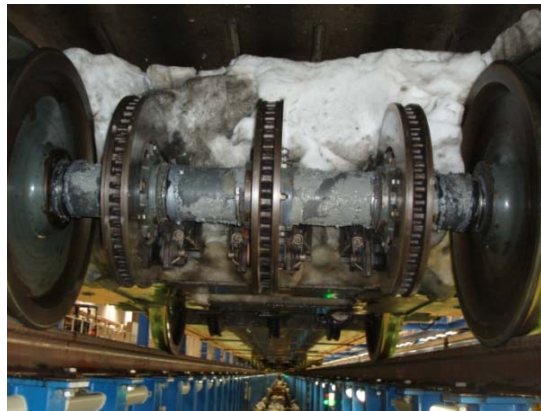
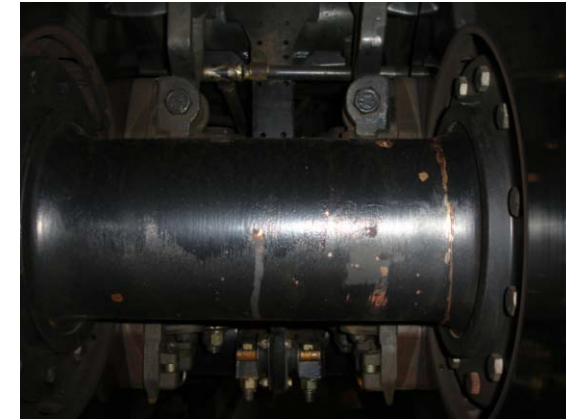
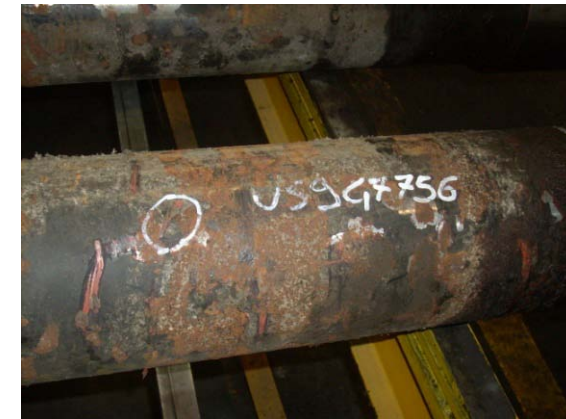
**Contact with external element
and starting of corrosion**

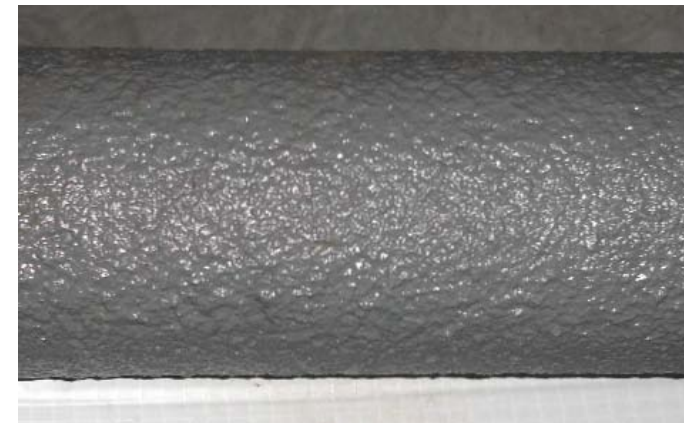
The 3 layers have, usually, a **total thickness of 4-5 mm**:

- Wash Primer, around 10 microns, for improving the adhesion to steel and protect from corrosion;
- Primer (high thickness), flexible and **reinforced with fibers**, for absorbing the impact energy;
- Protective Top-coat (Finish, high thickness), **reinforced with fibers**, for protecting against scratches and creeps.

The fibres guarantee a high level of consistence and structural resistance.

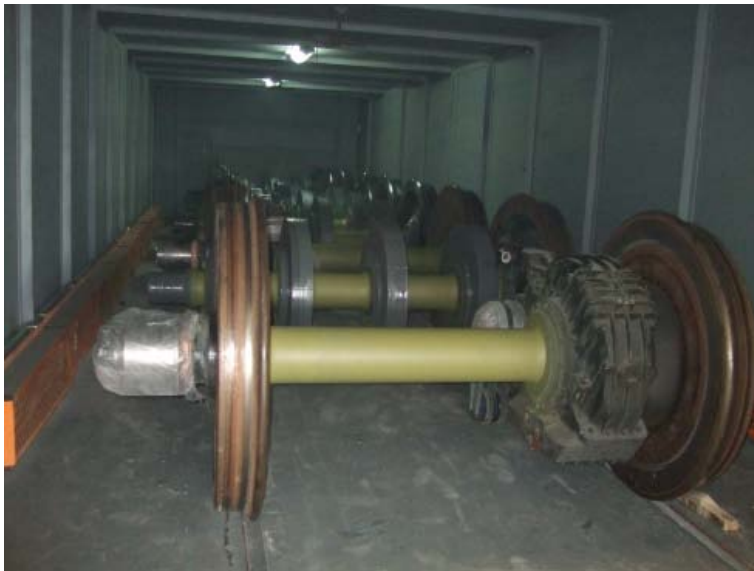
Drying of WP (first layer)

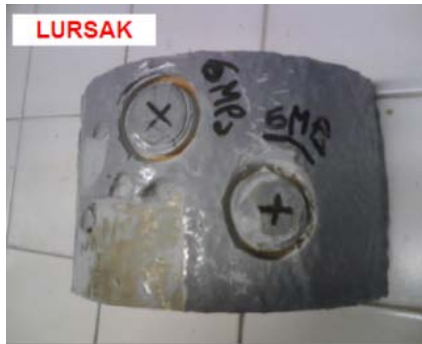
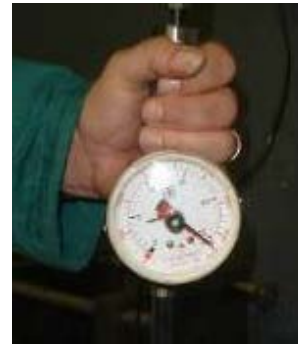
Coating adhesion (pull-off test)

No detachment of protective coating observed in the most severe condition (up to 25 MPa applied)

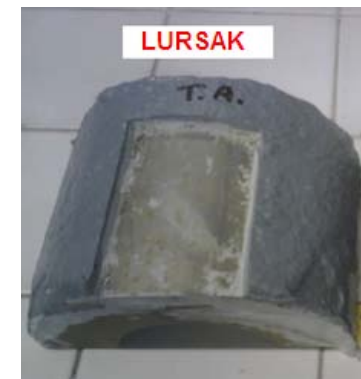
Impact test @ -25°C and R.T.

- _ Projectile Mass M: 0.587 kg
- _ Height of fall h: 2.08 m,
- _ Impact energy E: 12 J

No hole found in the protective coating and no alteration of axle surface has been detected.

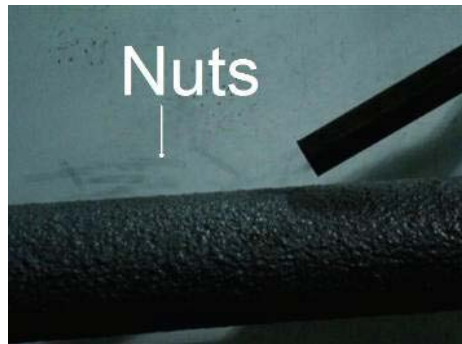
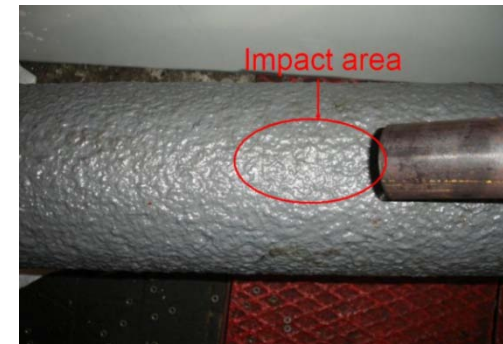
Gritting test

The gritting test defines the ability of a coating to protect the axle from damage due to repeated sand or grind blasting.

- _ Projectiles: 1 kg of steel nuts dropped on the painted axle surface;
- _ Height of fall h: 5 m

According to EN 13261, **LURSAK can guarantee the maximum level of protection to the axle (Coating loss level 1*) against the repeated sand or grind blasting.**

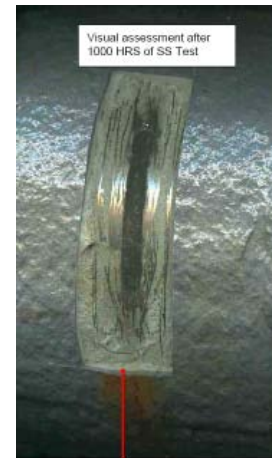
The maximum progress of corrosion, from the edges of the artificial aperture, after 1000 hours is about 0.70 mm: the limit allowed by EN 13261 is 2 mm;

LURSAK guarantees the protection against corrosion.

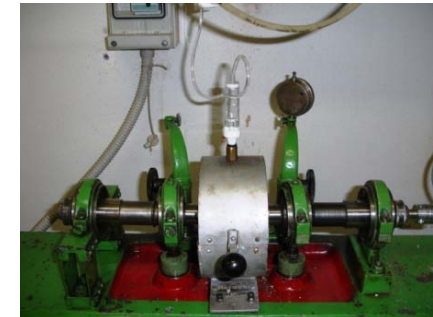
Coating resistance to cyclic mechanical stresses

Fatigue tests on specimen in A1N steel grade covered with coating determining the ability of the coating to resist cyclic mechanical stresses combined with a corrosive product (demineralized water “drop by drop”) dropping on specimen surface.

Each of the 4 specimen have completed the 5 stress levels required (170 -> 210 MPa) without showing any failure.

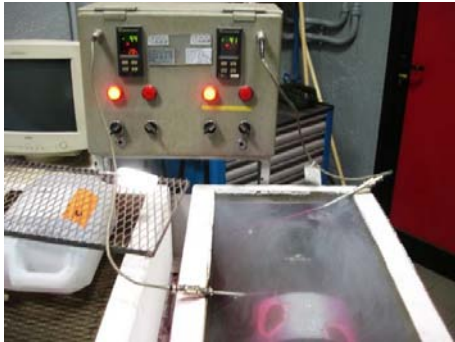
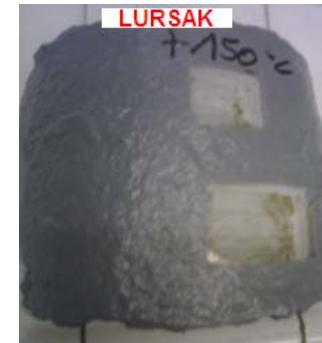
Impact test at -40°C and +150°C (EN 13261 required -25°C and R.T.)

_ Impact energy E: 12 J, as required by EN 13261.

No hole found, no alteration of axle surface has been detected.

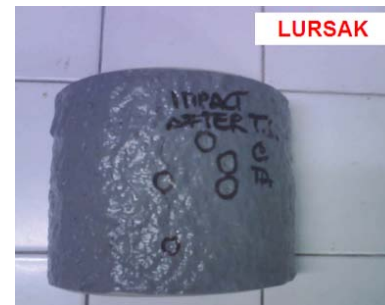
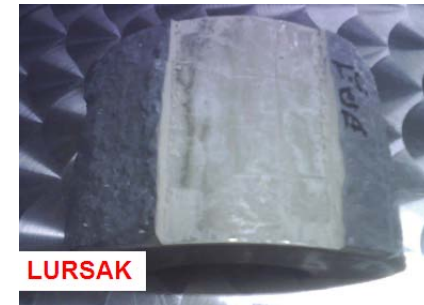
_ Ageing: 10 days of heating and cooling from +150°C to -30°C.

No hole found, no alteration of axle surface has been detected.

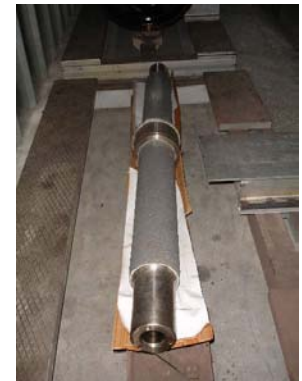
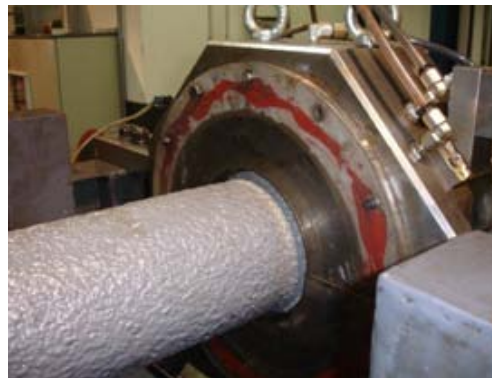
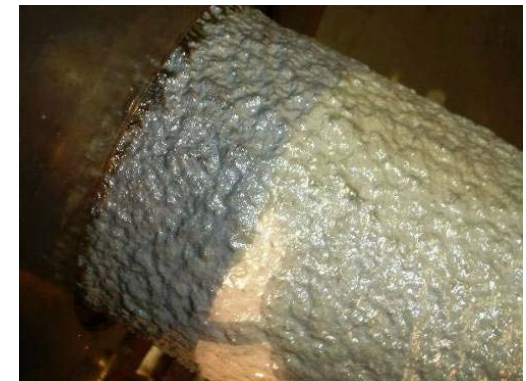
The aim of the fatigue test is the verification of LURSAK resistance when the axle is subjected to very high level of stress: a full-scale test axle painted with LURSAK, in aged condition, has carried out a fatigue test with the application of a completely reversed stress cycle (amplitude of 180 MPa) for 10 millions cycles.

The Visual and Ultrasonic Tests carried out at the end of fatigue test have confirmed that **LURSAK is able to resist for 10 millions cycles to the application of an high level of stress without any failure point.**

Braking stop from 150, 220 and 300 km/h	✓	
Fatigue test	Application of 180MPa for 10 millions cycles	✓	No failure point of LURSAK found
Flame test	DIN 54837, ISO 5658-2 and DIN 5510-2	✓	Product conformed

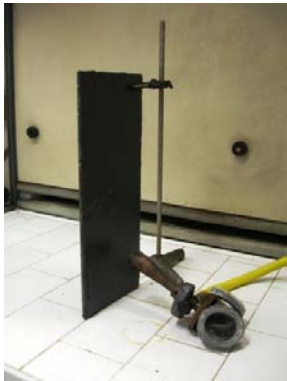
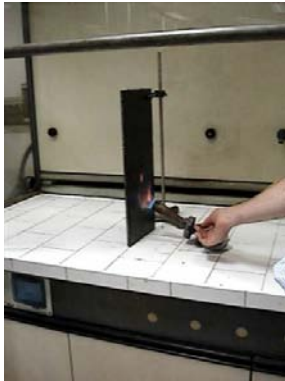
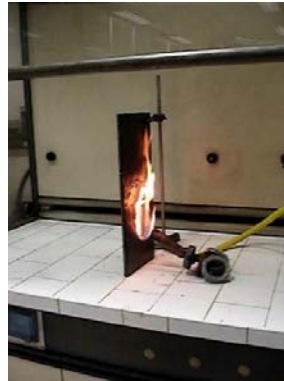
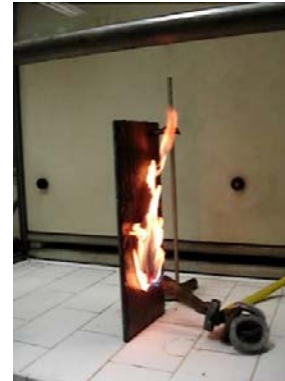
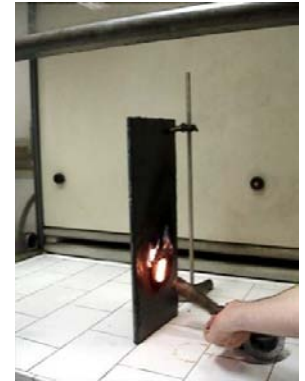
A flame test campaign have been performed on plates and specimen painted with fire proof version of LURSAK. In this test campaign, they are evaluated:

- _ fire behaviour, smoke emission and dropping behaviour according to DIN 54837;
- _ smoke toxicity in the test chamber ISO 5658-2 (evaluation according to DIN 5510-2).

The results are satisfying.
