University of Portland
School of Engineering
ME 421 – Failure Analysis
Fall 2011

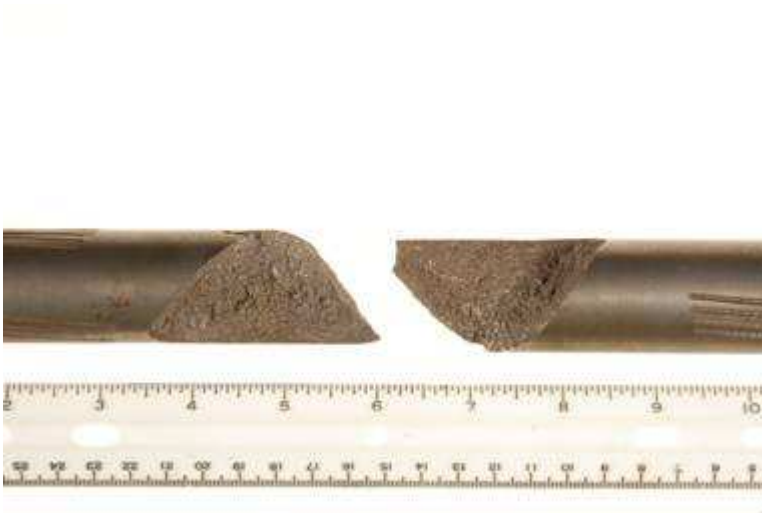
1) Below is a photograph of a broken bar. The failure was due to an overload, not due to fatigue. Answer the following questions:

- a) Does the failure appear to be ductile fracture or brittle fracture?
- b) How was the part loaded when it failed? Does it appear to have been predominantly torsion, predominantly bending, or predominantly axial tension/compression?
- c) What failure theory(s) would have been appropriate for the design engineer to use: maximum shear stress, distortion energy or maximum normal stress?
- d) Observe the actual specimen available outside my office. Are there signs of where the crack initiated at?
